# Manhole Inspection Summary

Manhole # S13MM\_039MH

**Location** Address: **ASHBURTON ST**

Cross Street: **GWYNNS FALLS PKWY**

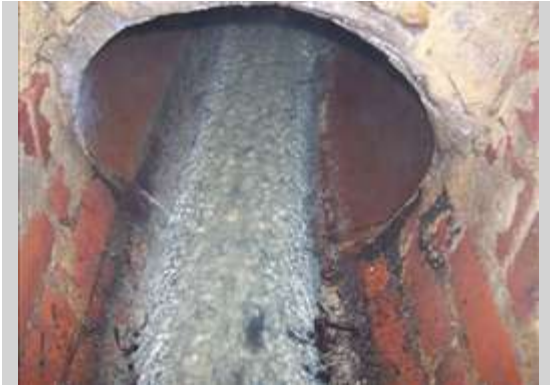
12 O'Clock Outflow

18 in. Circular Gravity Sewer  
Pipe Out @ 12 O'Clock

Pipe Height: **14.4** (in.) Rod and Bar  
Pipe Material: **Clay** ☐ Pipe Lined  
Invert Depth: **25.45** (ft.) Flow Characteristics: **Fast**  
Deposits: ☒ None ☐ Mud ☐ Sludge ☐ Debris ☐ Grease  
Silt Depth: (in.) Deposits Extent:  
Infiltration: **None** Pipe Seal Cond: **Sound**

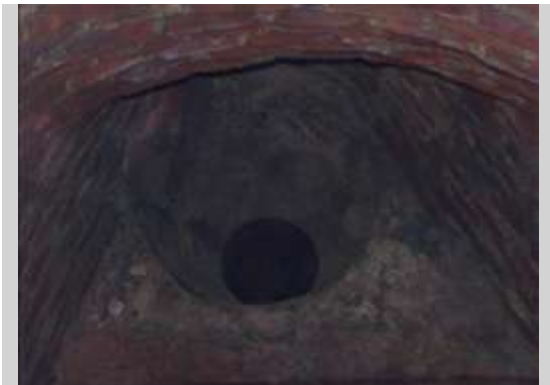
6 O'Clock Inflow

18 in. Circular Gravity Sewer  
Pipe In @ 6 O'Clock

Pipe Height: (in.) Direct  
Pipe Material: **Clay** ☐ Pipe Lined  
Invert Depth: **9.80** (ft.) Flow Characteristics: **Fast**  
Deposits: ☒ None ☐ Mud ☐ Sludge ☐ Debris ☐ Grease  
Silt Depth: (in.) Deposits Extent:  
Infiltration: **None** Pipe Seal Cond: **Sound**

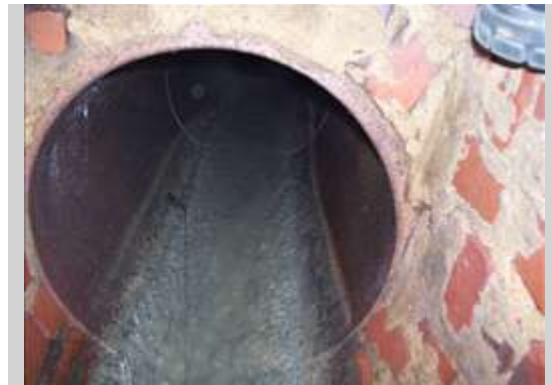
Drop In @ 6 O'Clock

Drop: **Inside** **Direct**  
Angled: Reading: (ft.)  
Inv Depth: **25.10** (ft.)  
Drop Condition: **Open**
